**Name of work:** Structure Safety Audit of Existing Ghalib Apartment Co-operative Group Housing Society located at Parwana road Pitampura, Delhi

## **STRUCTURE AUDIT REPORT**

The President  
Ghalib Apartment  
Co-operative Group Housing Societies Pitampura,  
Pitampura, Delhi-110083.

M/S Swati Consultants  
504, Sachdeva Corporate Tower, Plot  
No. 8, Sector-8, Rohini,  
New Delhi-110085.

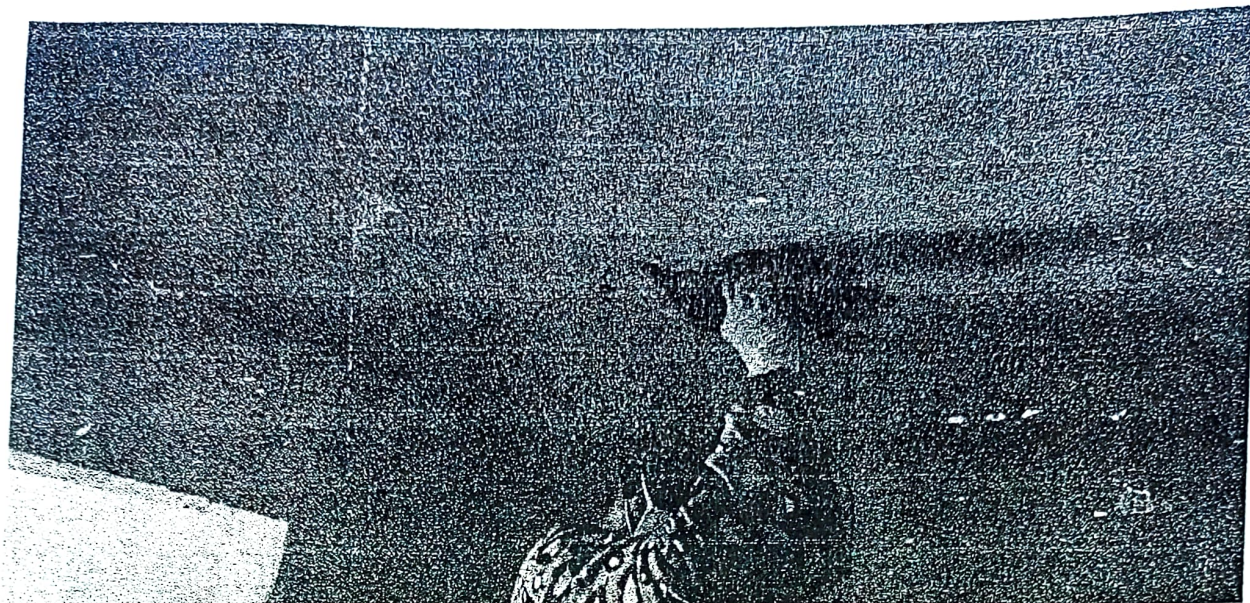
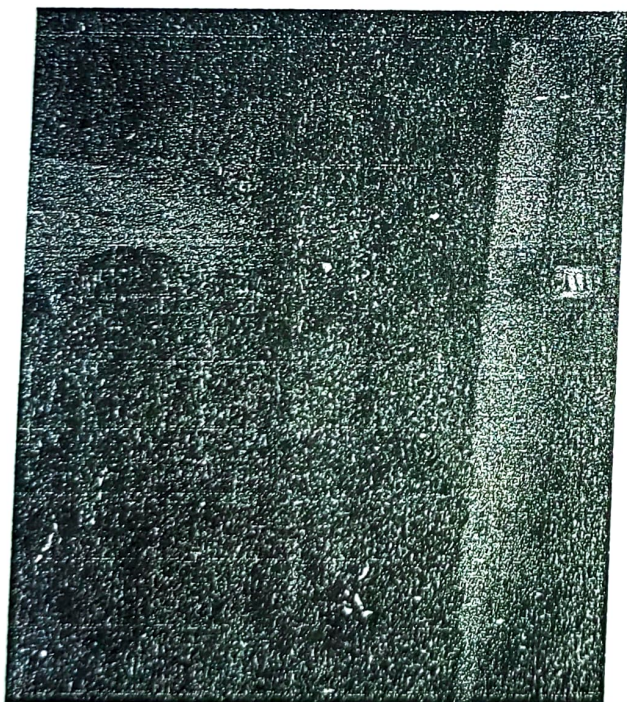
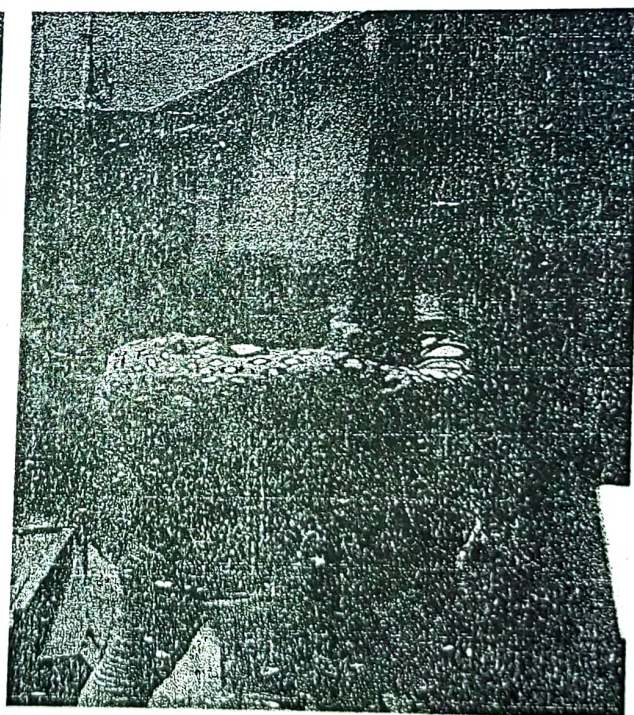
**DISTRESS MAPPING**

3. The columns are approximately 230X230 in sizes.
4. Dampness has been observed at several places in the building.
5. Due to seepage from service pipe lines, rain water pipe and toilets the rusting has taken place in steel reinforcement, concrete strength got reduced and structure has weakened. Roof treatment done has been found to be damaged and leakage has been observed in top floor slabs and beams.

6. It has been observed that there are Cracks, Blistering, Delamination & Efflorescence, present in the walls.
7. Spalling of concrete has been observed at many places.
